National River Conservation Directorate  
Department of Water Resources,  
River Development & Ganga Rejuvenation  
Ministry of Jal Shakti  
Government of India

# STATUS OF AERIAL/DRONE SURVEY OF PERIYAR RIVER BASIN

September 2024

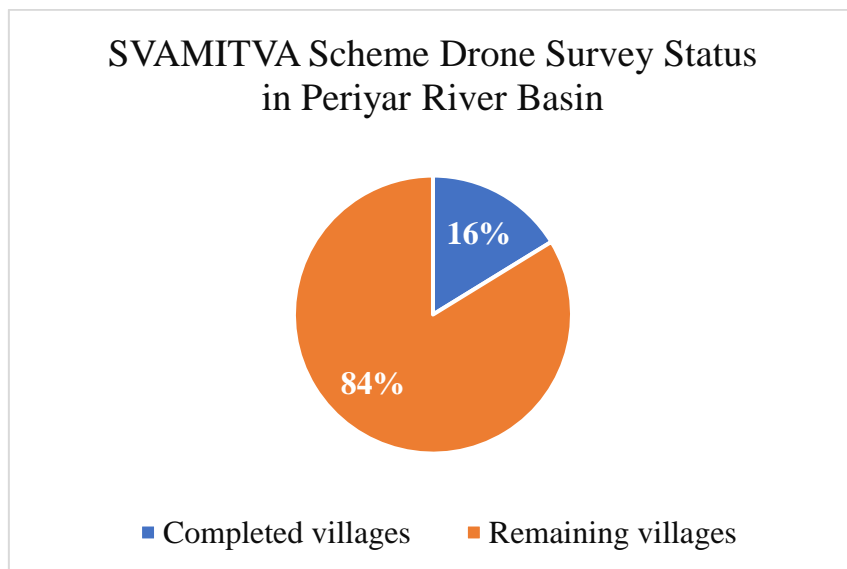
out of the 1415 notified villages in the State (<https://svamitva.nic.in/>), out of which 25 (out of a total of 154 villages) fall within the Periyar River Basin. The status of drone survey performed under the SVAMITVA Yojana is presented in Figures 2 and 3.

**Figure 2: Status of drone survey under the SVAMITVA Yojana - Periyar River Basin**

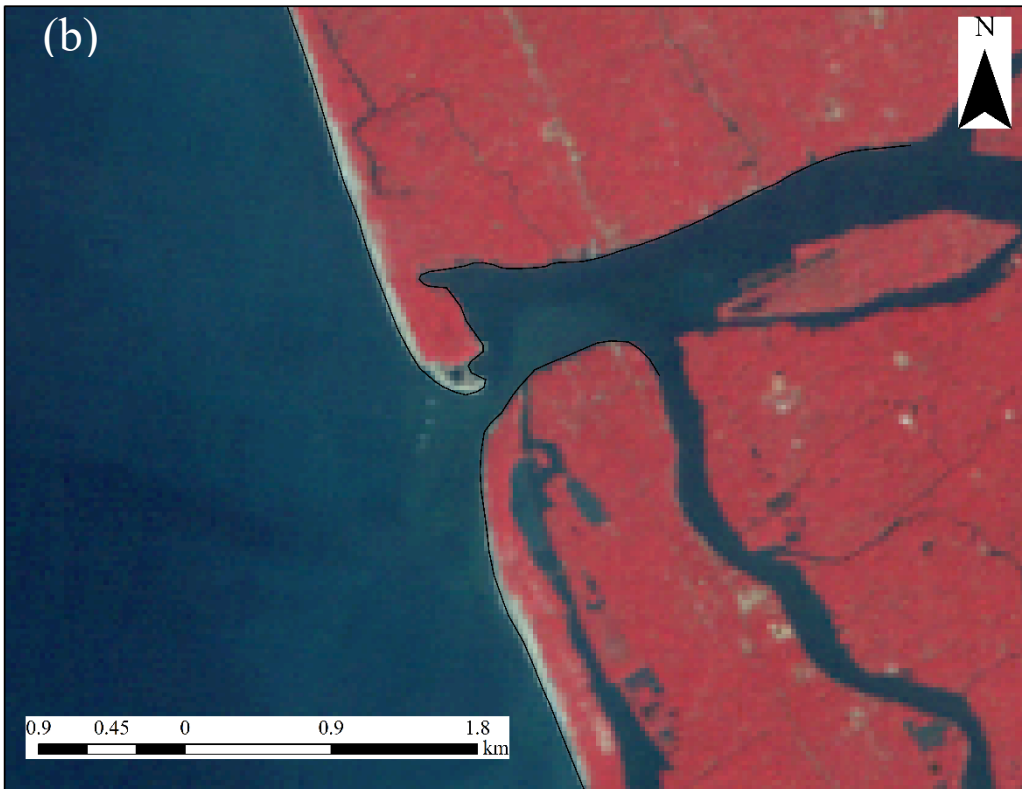
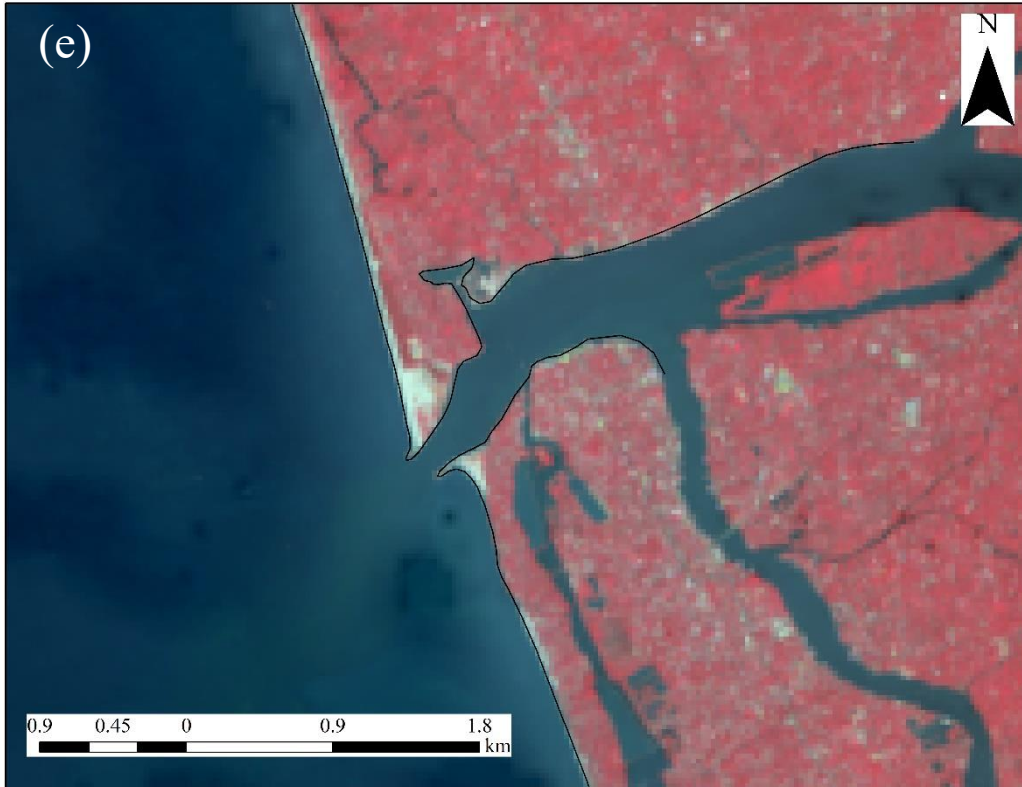
The coastal regions of Munambam and Vypin in Ernakulam district, Kerala, are highly dynamic, facing substantial coastal erosion and accretion due to natural processes and human interventions. Munambam, located at the northern tip of Vypin Island, where one segment of the Periyar River meets the Arabian Sea, experiences significant erosion, particularly during the monsoon season. Strong tidal currents and wave action during the southwest monsoon cause severe shoreline retreats, as evidenced in various studies on the coastal dynamics of Kerala (Thodi et al., 2023; Noujas et al., 2013). Our preliminary analysis using satellite imageries of the area for the period between 1973 and 2024 clearly depict changes in the shoreline at Munambam (Figure 4). Sentinel-2 imageries of 10-m spatial resolution for the period 2016-2024 also clearly indicate changes in the shoreline (Figure 5). The breakwater at Munambam-Azhimugham has caused accretion, with significant sand deposition on both sides of the structure and reshaped the coastline. A depositional feature has developed in the river near Munambam due to sediment accumulation. It was initially noticed in 2015 and over the years it had increased in size. Overall, the changes in the coastal zone were identified by comparing multispectral data from the LANDSAT images of the years 1973 (Landsat 1 MSS), 1988 (Landsat 5 TM), 2001 (Landsat 5 TM), 2008 (Landsat 5 TM) 2017 (Landsat 8 OLI/TIRS) and 2024 (Landsat 9 OLI-2/TIRS-2). Sediment accumulation at this site is influenced by tides, changes in the tidal pattern and human interventions along the coastline, causing alterations in the natural flow of sediments.

**Figure 4: Landsat Satellite images of Munambam (a) 1973 (b) 1988 (c) 2001 (d) 2008 (e) 2017 (f) 2024**

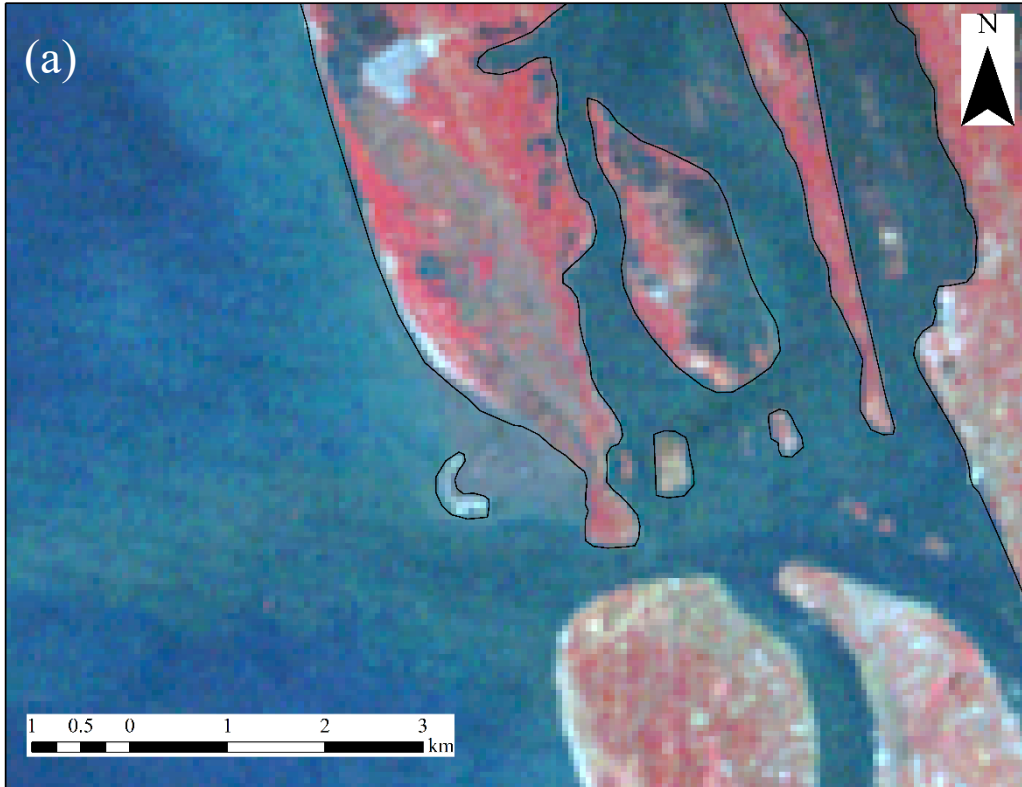
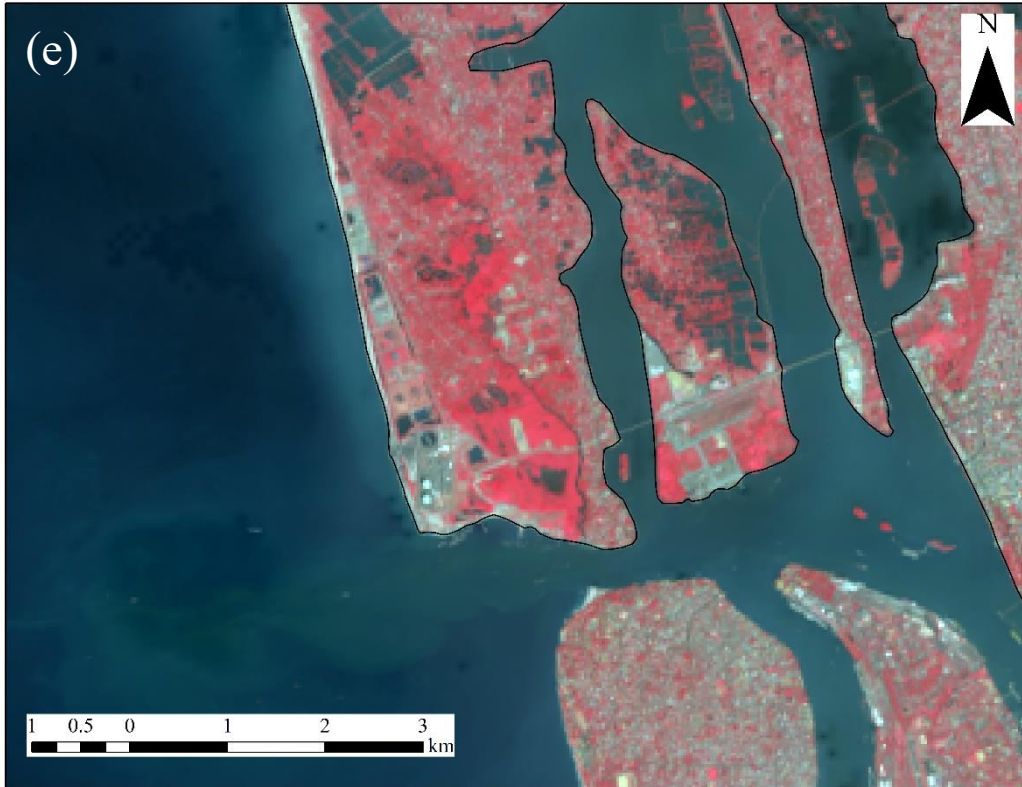
It is also observed that coastal defence structures such as breakwaters and groynes have altered the natural sediment distribution in different parts of the Vypin island, leading to localized erosion in some stretches, and accretion in some others. This is clearly evident from Figure 6 that a significant change in the shoreline at Vypin has occurred. Construction of breakwaters and groynes has accelerated the accretion process, leading to the deposition of sand along both sides of these structures, reshaping the coastline over time. Also, the construction of a port at Vypin has intensified the shoreline change (Figure 7). Also, sediment influx from the Periyar River along with wave action contributed to accretion in some areas leading to an expansion in the land area, whereas some other stretches lost land to the sea.

**Figure 6: Landsat Satellite images of Vypin (a) 1973 (b) 1988 (c) 2001 (d) 2008 (e) 2017 (f) 2024**

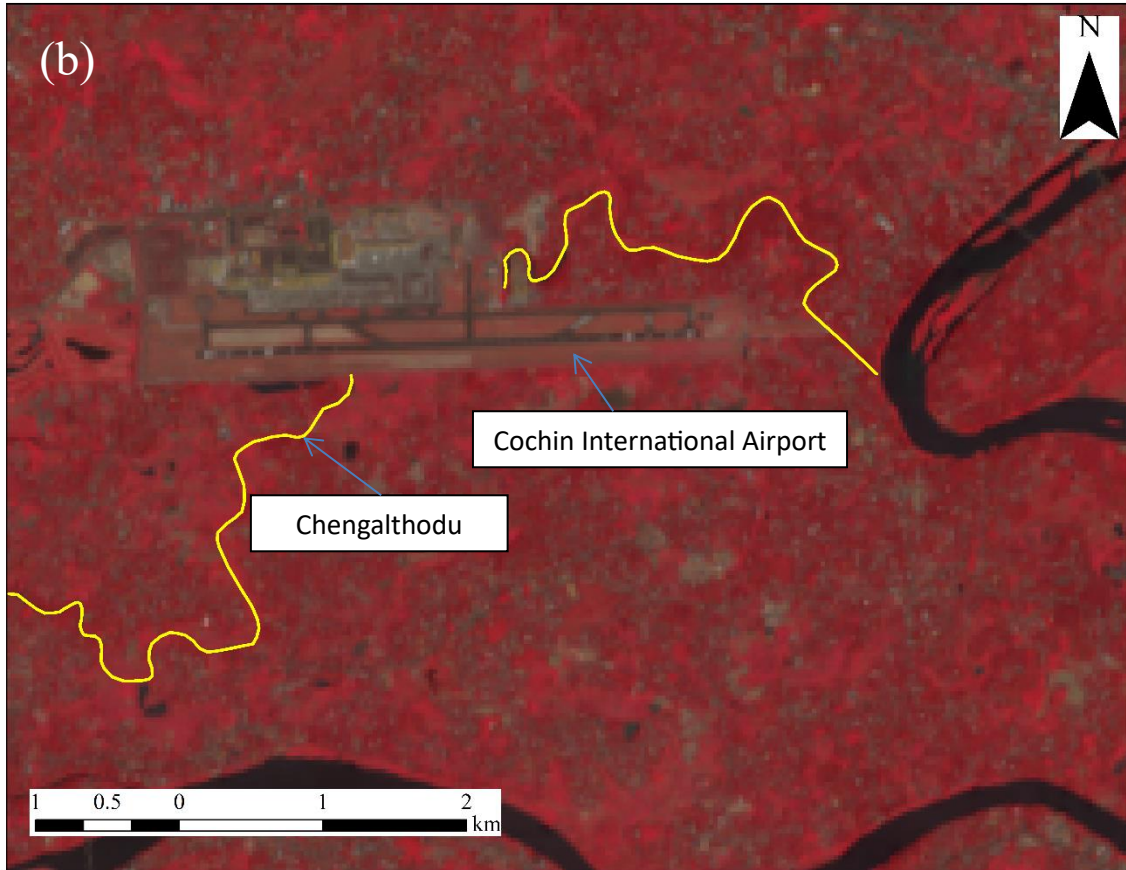
Comparison of the satellite images of 1988 and 2024 revealed that the Chengal Thodu, a creek that served as a distributary from the Periyar River, has been blocked post-construction of the Cochin International Airport. Figure 10 shows the satellite images of Aluva before and after the construction of the Cochin International Airport. The runway of the airport, which was built on the lower floodplains of the river basin by reclaiming paddy fields, obstructs the natural flow of the Chengal Thodu. It is reported that the realignment carried out to facilitate the construction of the runway narrowed the creek. Prior to the construction of the Idukki Reservoir, approximately one-fourth of the water in the Periyar River flowed through the Chengal Thodu. Now, it is a degraded waterway with stagnant water during the normal season.

**Figure 10: Satellite images of Aluva before and after construction of the Cochin International Airport (a) Landsat-5 TM (1988) (b) Landsat-9 OLI-2/TIRS-2 (2024)**
